Service Bulletin

SB No. LCD04092901R2

Subject: LCD Entertainment Screen Blank
Serial Number: ALL

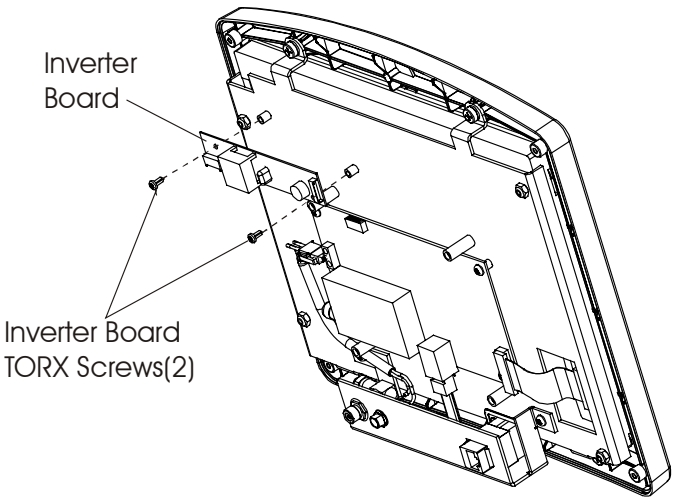
DESCRIPTION:
Console Screen is blank. There is sound with headphones plugged in.

SOLUTION:
Replace Inverter Board with Part No. GK32-00002-0004.
